# Manhole Inspection Summary

Manhole # S35AA1040MH

Insp Date: **1/18/07 9:37 AM**

**Location** Address: **3435 UNIVERSITY PL**

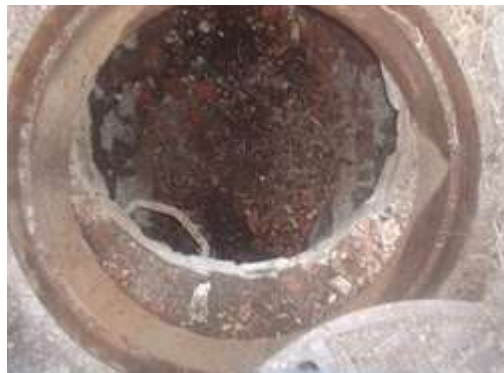
Top View

Frame leaks. Channel debris.

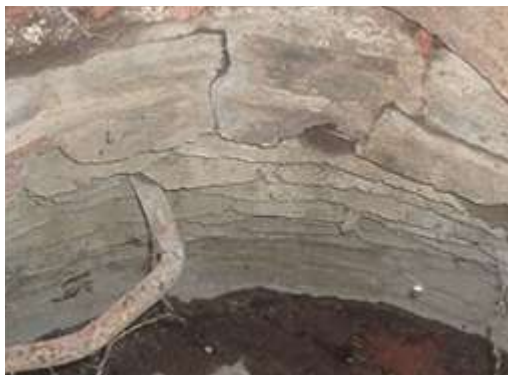
Defect

Adjustment deterioration and infiltration. Corbel infiltration.

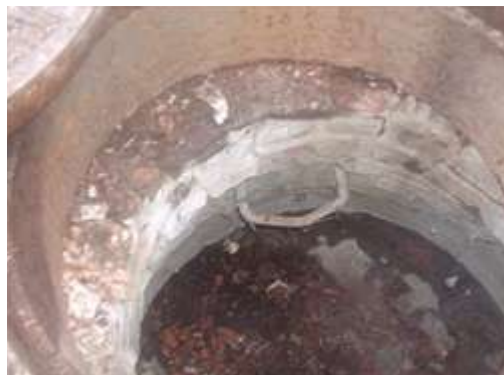
Defect

Frame offset. Adjustment deterioration, loose brick and infiltration. Corbel infiltration.

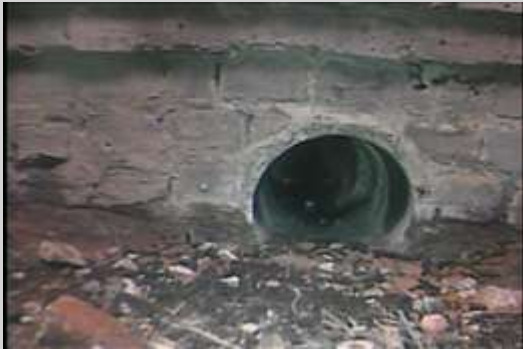
8 in. Circular Gravity Sewer  
Pipe Out @ 12 O'Clock

Deposits: ☐ None ☐ Mud ☐ Sludge ☒ **Debris** ☐ Grease

Silt Depth: **1** (in.) Deposits Extent: **Light**
